ALWAYS FAITHFUL HOME INSPECTION LLC

PROPERTY INSPECTION REPORT

1234 Main Street
Tucson, AZ 85745

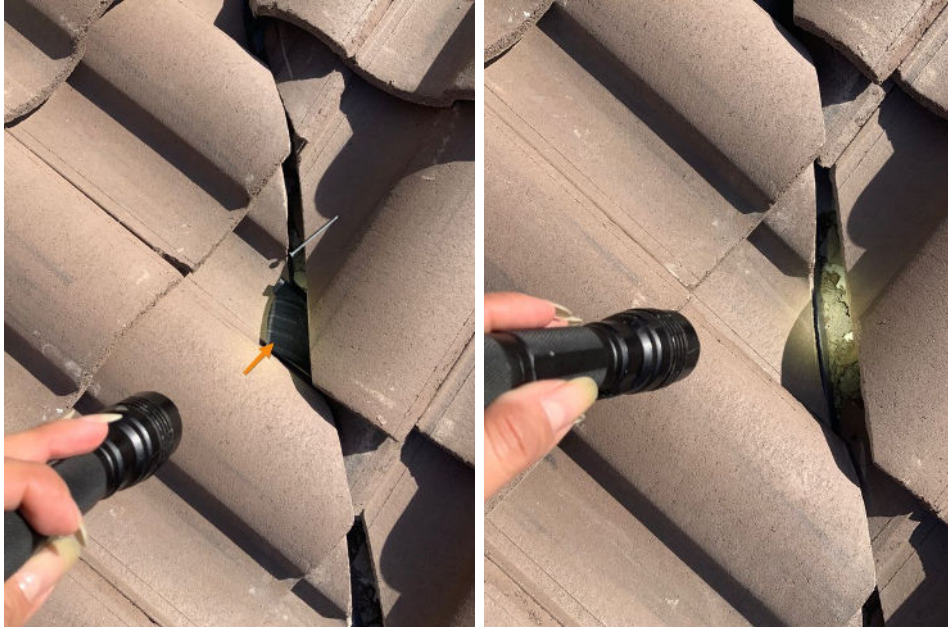
2.1.1 Roof condition

Significant amounts of debris evident. Recommend removing the debris to prevent accelerated deterioration of the roof coating or possible moisture intrusion.

Contact a qualified professional.

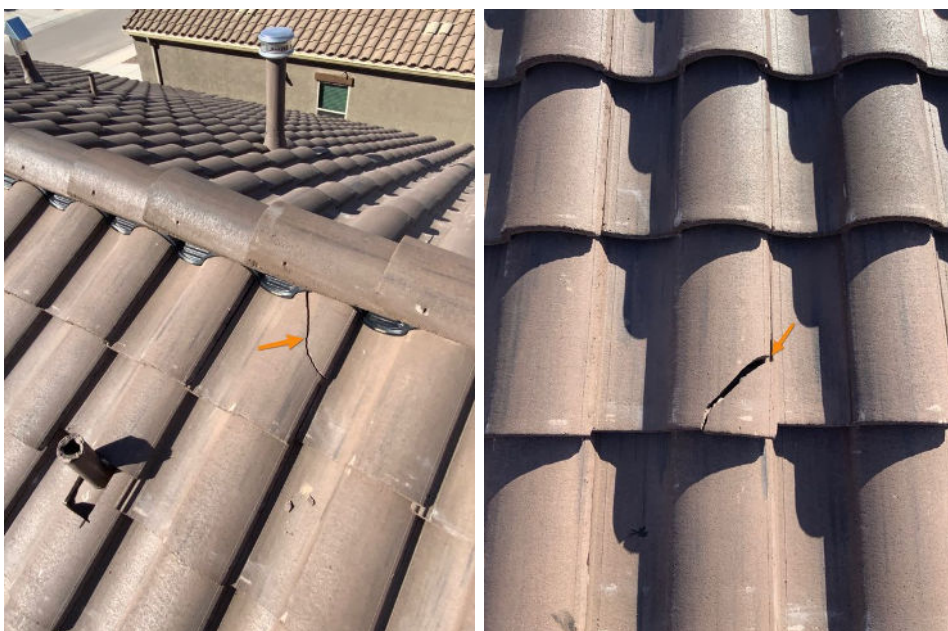
2.1.2 Roof condition

BROKEN/SLIPPED/CHIPPED TILES

One or more broken/slipped/chipped tiles noted along the roofing structure. Recommend a licensed contractor evaluate for repair/replacement.

Contact a qualified professional.

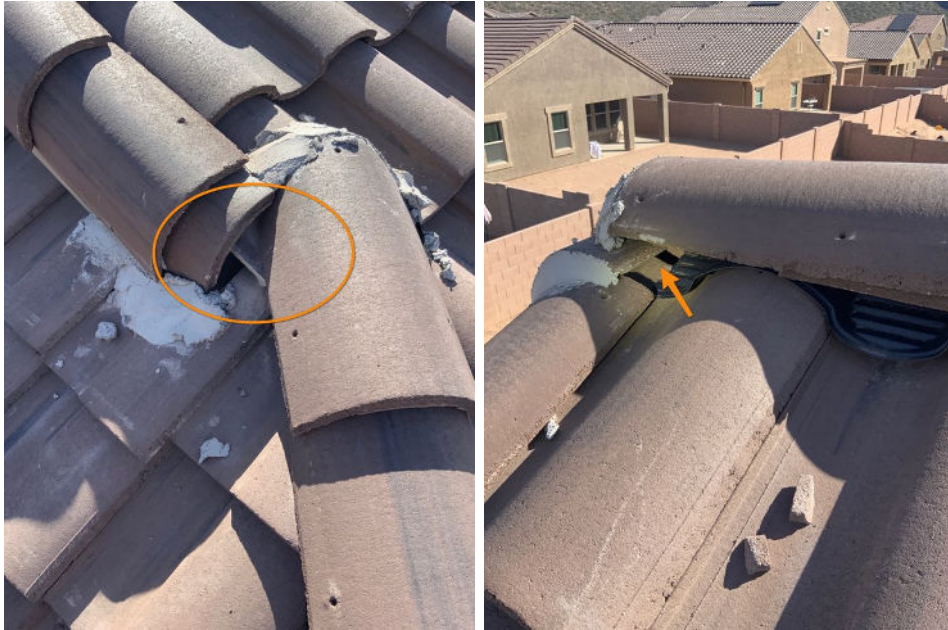
2.1.3 Roof condition

OPEN PENETRATIONS

Open/unsealed roof penetrations noted. Recommend sealing the penetrations to prevent a source of water intrusion.

Contact a qualified professional.

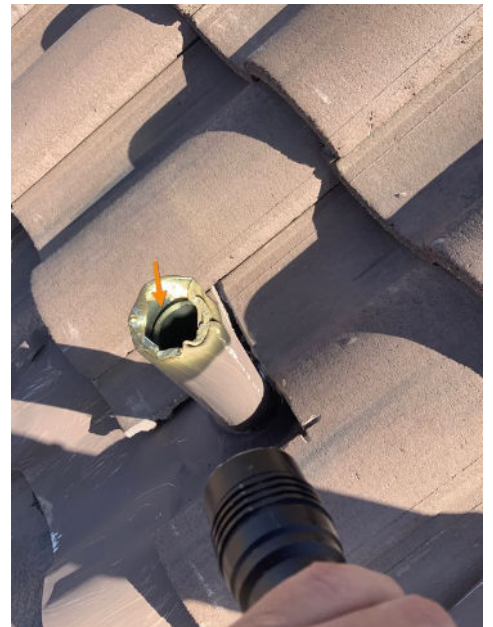
2.3.1 Vent Caps

MISSING/INADEQUATE CRIMP

Vent cap metal cover is not properly crimped at the time of inspection. Recommend licensed contractor to evaluate for repair to prevent water intrusion between vent stack and metal cover.

Contact a qualified professional.

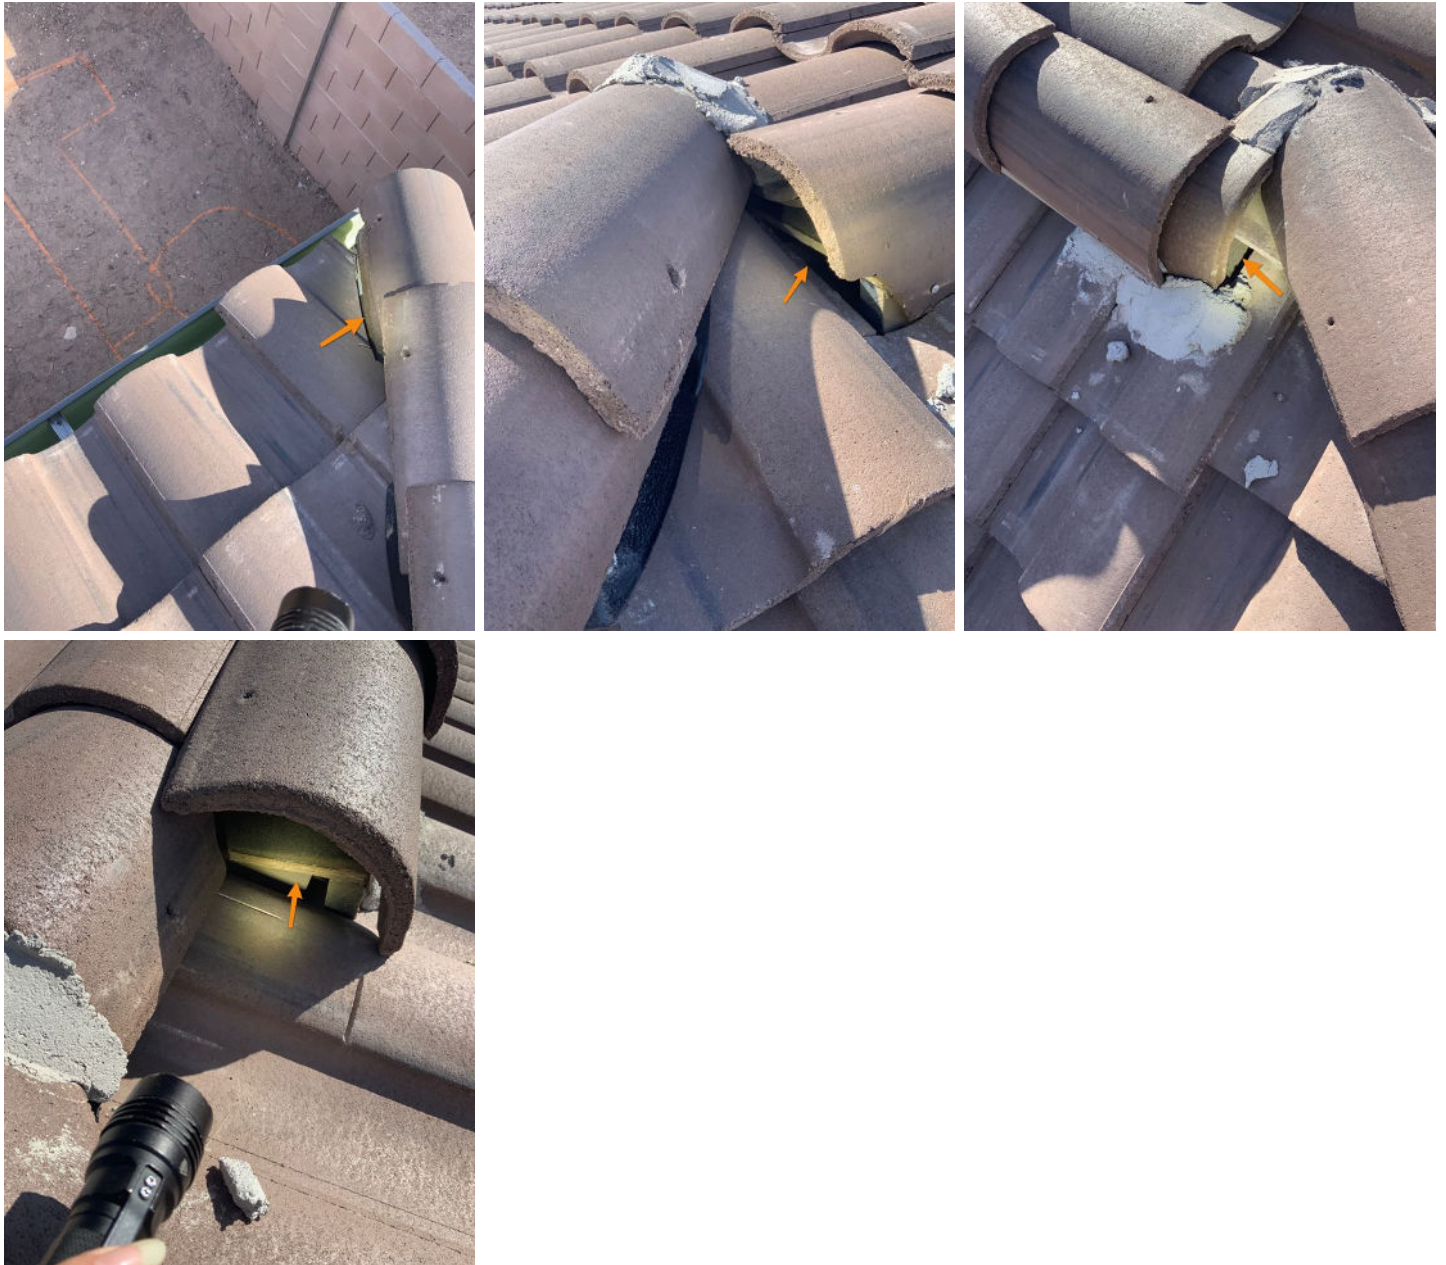
2.4.1 Flashing

MISSING FLASHING

Areas of missing flashing noted (see photos for specific areas). Recommend licensed contractor to evaluate for repair to prevent water intrusion.

Contact a qualified professional.

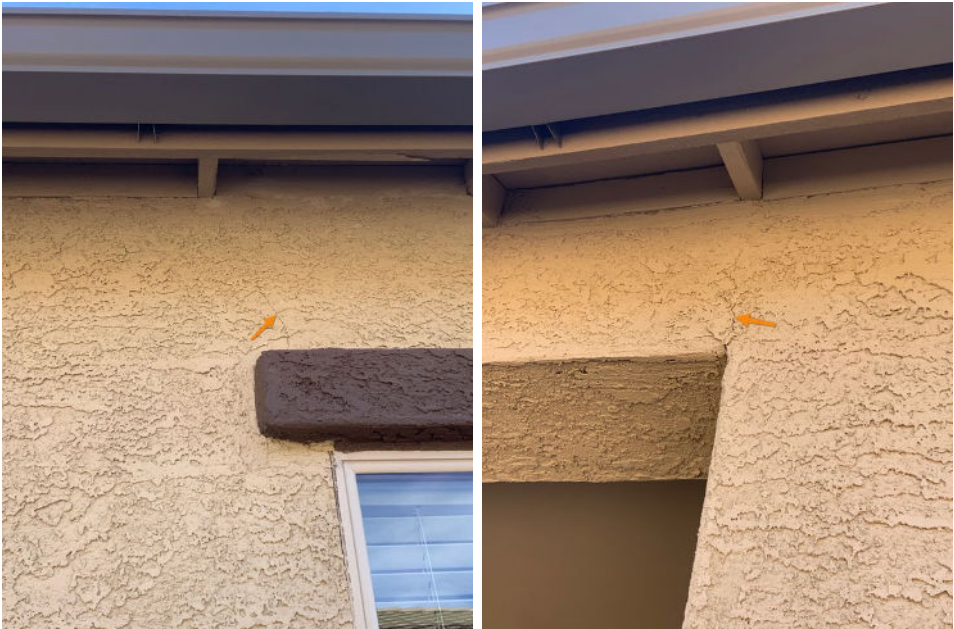
2.6.1 Exterior walls

MINOR CRACKS

Minor cracks cracks noted in the exterior walls of the home that do not appear active but should be monitored for continued growth/deterioration.

Contact a qualified professional.

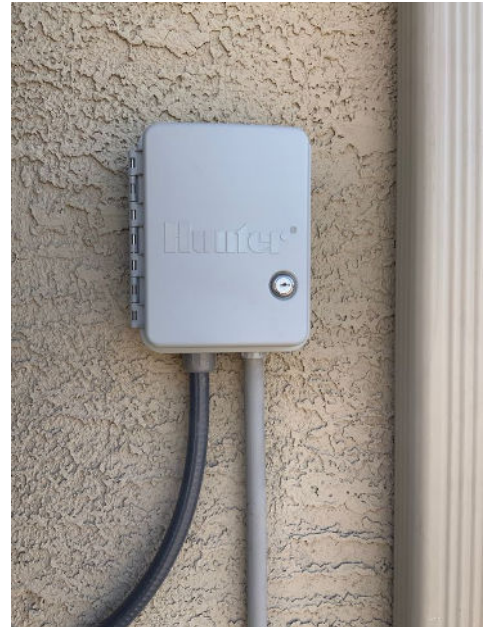
Supply and Waste Plumbing

SPRINKLER SYSTEM NOTED

Underground sprinkler/irrigation system noted. These systems fall outside the scope of the typical home inspection as it could cause disturbances in the programmed schedule and we are unable to detect underground leaks. If this system is intended for use it is recommended to have it evaluated by a specialist.

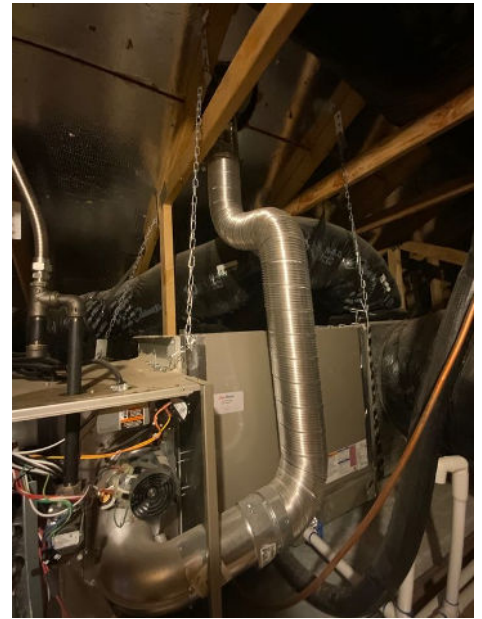
Heater Condition: Furnace
Location
Garage

Heater Condition: Ventilation
Type
Single Wall Metal

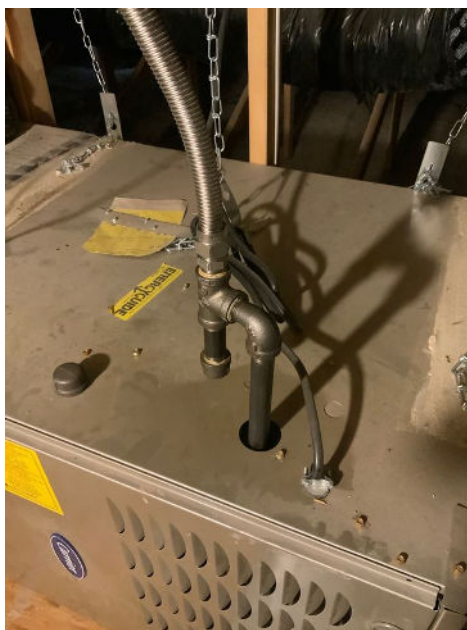
**Heater Condition: Gas valve condition**

Appears satisfactory and functional at the time of the inspection.

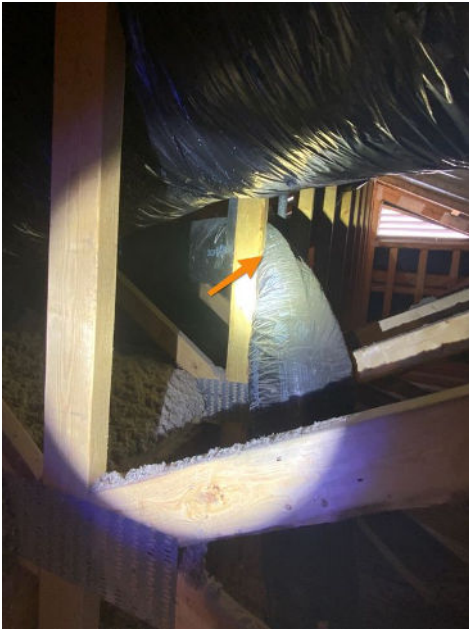
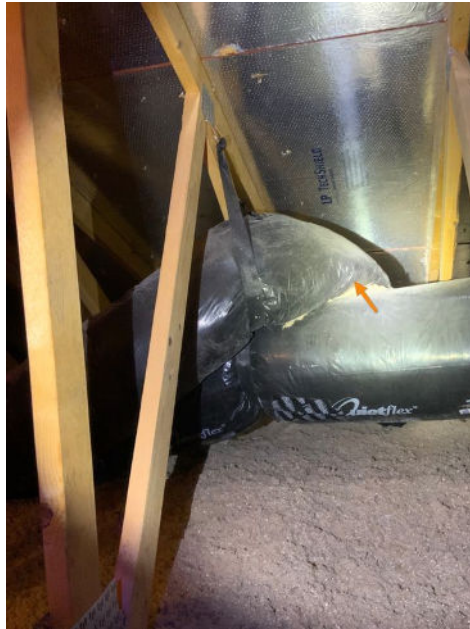
7.1.1 AC Compress Condition

Conditioned air ducts appear to be bent/obstructed at the time of inspection. Recommend licensed contractor to evaluate.

Contact a qualified professional.

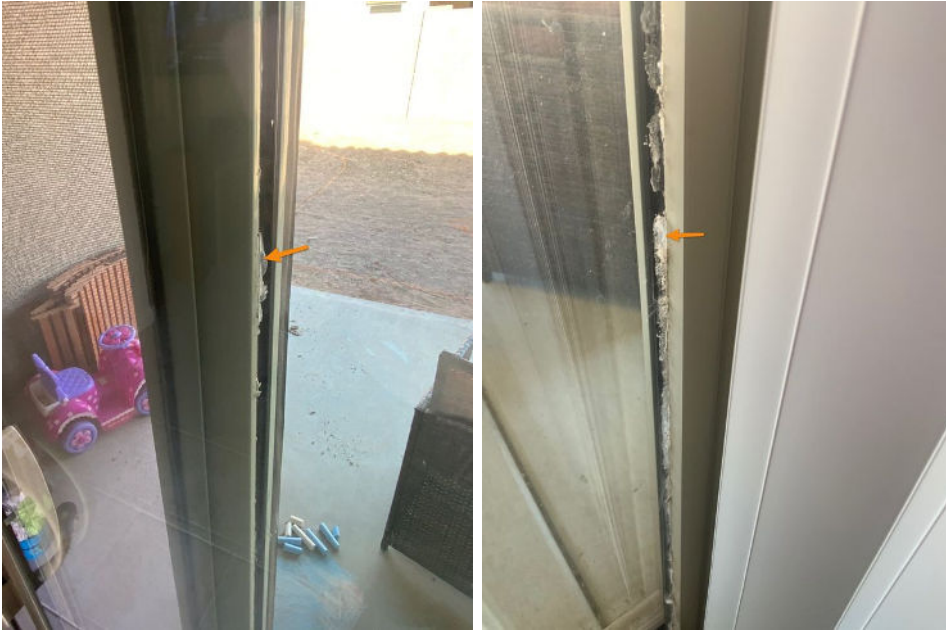
20.1.2 Doors

PREVIOUS REPAIRS

Contact a qualified professional.

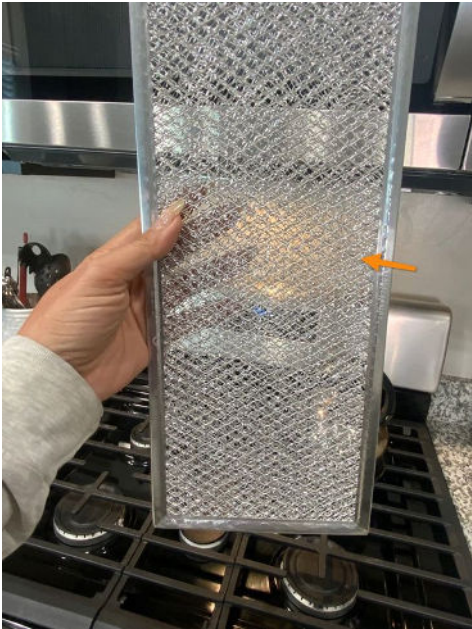
21.12.1 Exhaust Fan

NO CARBON FILTER

Contact a qualified professional.
